PARABRISAS CITSA DE MEXICO S.A. DE C.V. TEST REPORT

ANSI Z26.1-1996, AS-2 testing on Pruebas de muestra de material filtrasol de 4 mm

103636861GRR-001b

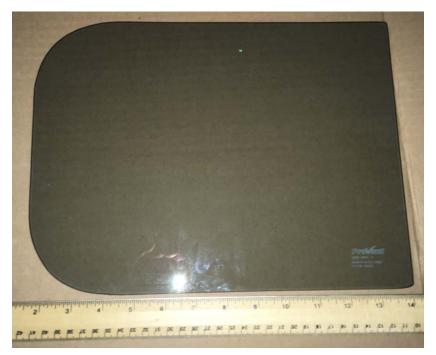
Figure 1: Typical sample as received

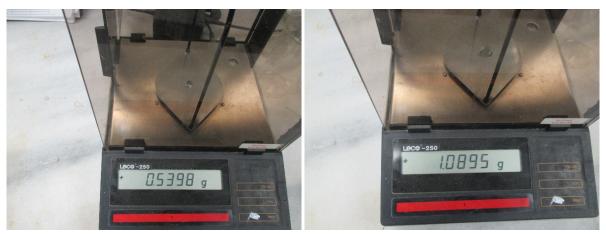
Figure 4: 5.7. Fracture Test Fragment Mass of Sample 1

FRAGMENT GREATER THAN 4.25 g			
PART	INDIVIDUAL	INDIVIDUAL IN	DISPOSITION	
		CLUSTER		
1	No (0.54 g)	No (1.09 g)	Conforming	
2	No (0.46 g)	No (0.57 g)	Conforming	
3	No (0.62 g)	No (1.06 g)	Conforming	
4	No (0.47 g)	No (0.85 g)	Conforming	
5	No (0.87 g)	No (0.82 g)	Conforming	
6	No (0.57 g)	No (1.21 g)	Conforming
